MIES VALUE ADDED SERVICES

—THERMOGRAPHY—

Description- location SAMPLE

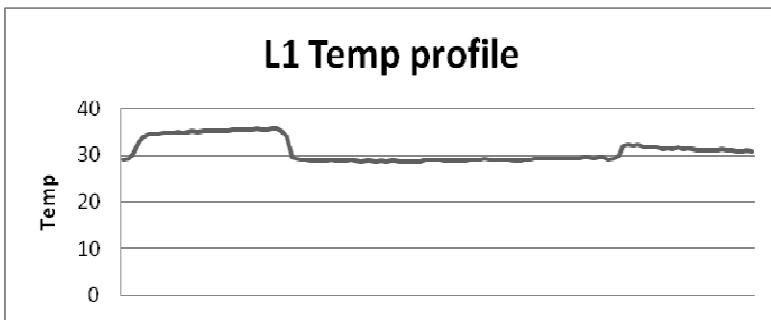
Incident Summary	
Location	Engine Room
Detail	Main Bussbar
Equipment	Incommer 08
Incident Date	12/12/2009 2:53:06 PM
Diagnosis	Poor ventilation inside main switchboard
Recommendation	Install fans to correct ventilation inside MSB
Severity	1. High
Units	°C
Global Emissivity	1.00

Spot Meter	Emissivity	Temp*
SP1	1.00	30.7
SP2	1.00	33.6
SP3	1.00	30.0
Li1	1.00	32

Urgent attention required.

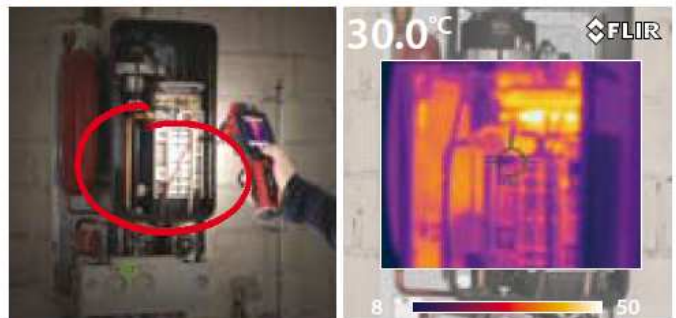
Failure of a domestic gas boiler installation displayed using the PiP function. The FLIR i50 is the only IR camera in its class with built in illuminating lights ensuring quality visual images regardless of the on site conditions.

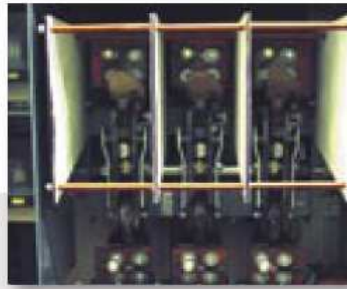
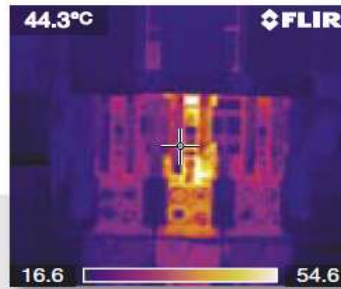
The thermal image clearly shows an overheated connection which can not be spotted by the naked eye. An undetected failure in this connection can lead to a costly power outage.

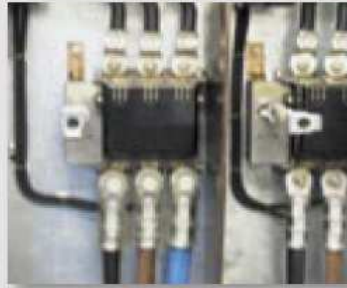
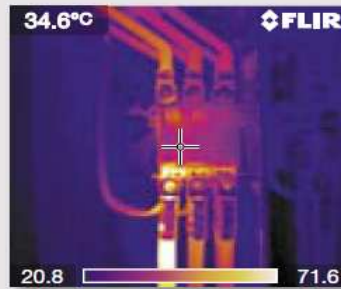
Loose or badly connected cables start to overheat. If left unrepaired, heat can rise to a point where cables start to melt or, even worse, set the environment on fire.

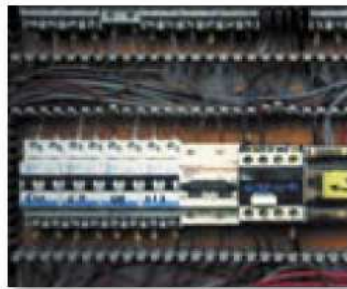
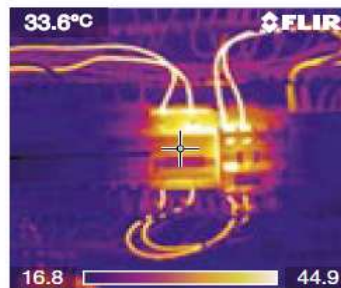
Overheated electrical circuits are commonly detected with the help of a thermal imaging camera. Inspections can however be safely performed while systems are under load, without hindering production and without putting the inspector in harms way.

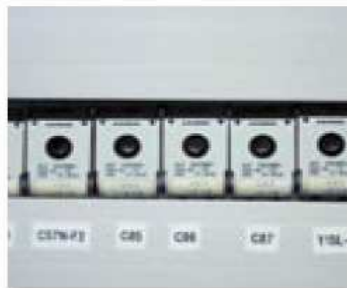
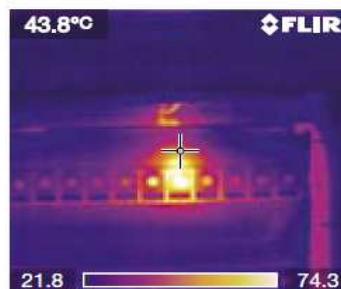
The thermal image clearly shows a defect or an overheated fuse. It can have very severe consequences. An entire production line can be shut down for several hours if this problem is not timely fixed.
